# Service-Information

Group: 11 Engine	November 1982	Bulletin No.: 11 019 81 (2031)
---------------------	------------------	-----------------------------------

RE: ENGINE MODIFICATIONS

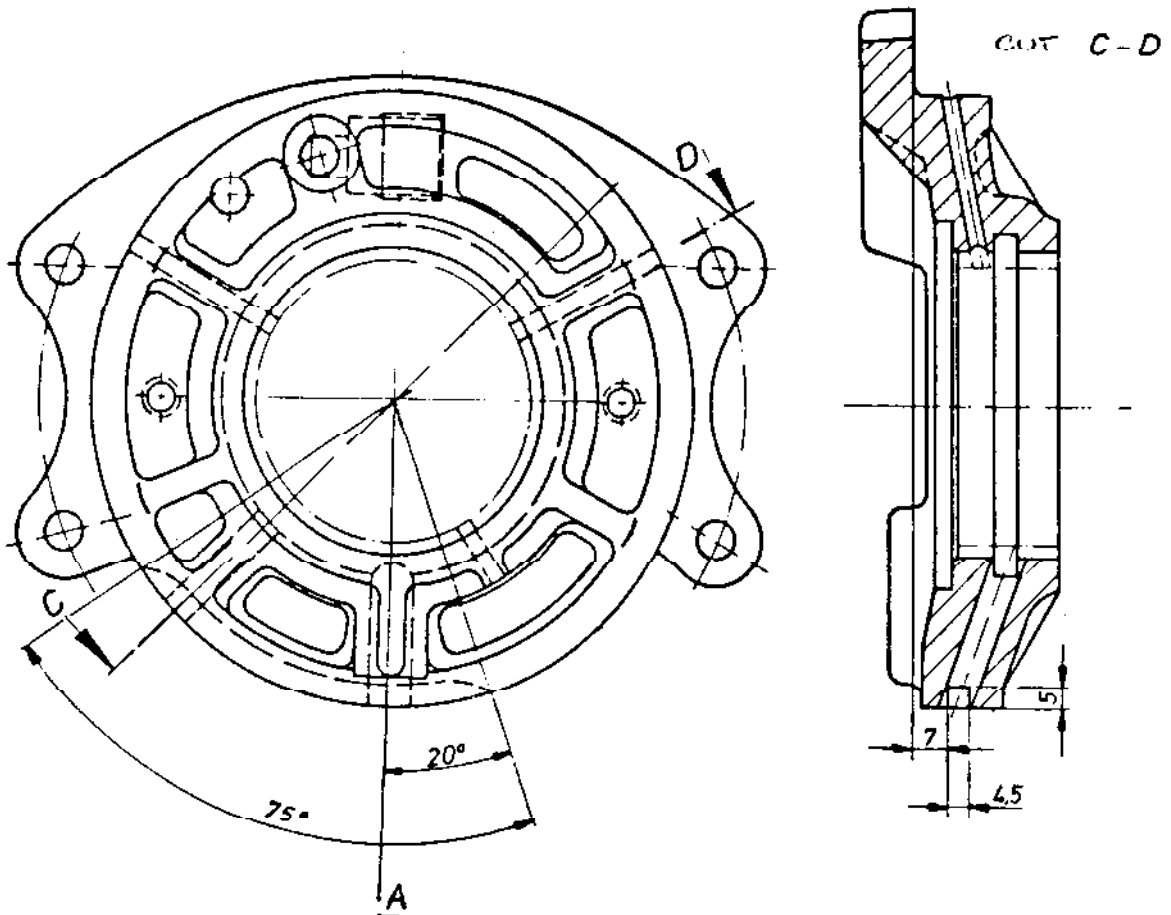
When an "Alcan" crankcase is used as a replacement on models which utilize a duplex (double row) timing chain camshaft drive (models 1970 to 1978), you must do one of two things:

If the above-mentioned modification or exchange is not done, no oil pressure will be obtained.

When an "Alcan" crankcase is used as a replacement on models produced before the above-listed VIN numbers that utilize a single row timing chain camshaft drive system (models 1979-1980), the only modification required (assuming that the outer distribution passage exists) is to ensure that the oil passageway A (found on Diagram #1) has a minimum diameter of 6.2 mm $\varnothing$ . If it does not, you must enlarge it to this figure or replace it with part No. 11 11 1 337 293 main bearing holder.

- (1) replace the front main bearing holder with a new design, part No. 11 11 1 259 593,
- (2) modify the existing main bearing holder to provide an oil distribution passage on the outer edge.

If you choose to modify the main bearing holder rather than replace it, use drawing below:
